USAARL REPORT NO. 72-07

DYNAMIC AND CRASHWORTHY EVALUATION
OF THE UH-1B, C, D, H, MEDICAL ATTENDANT'S SEAT

January 1972

U. S. ARMY AEROMEDICAL RESEARCH LABORATORY

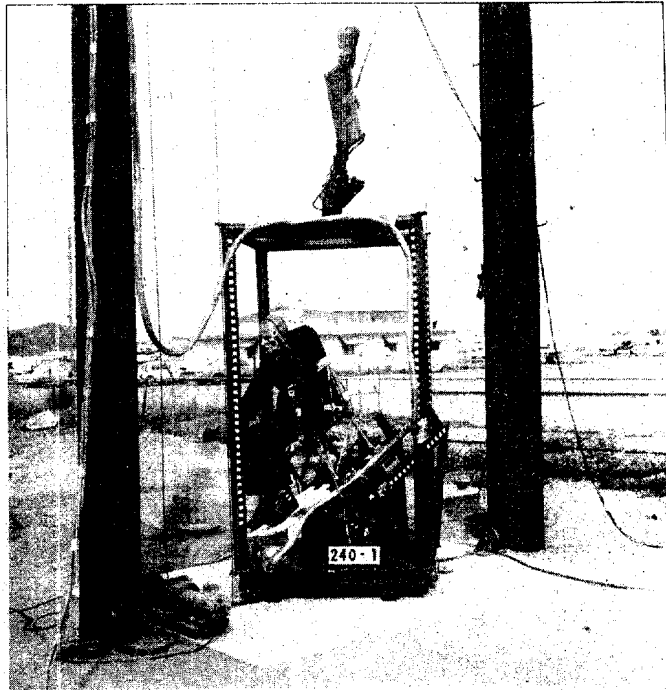
Figure 16. Seat Configuration 1 before Test 1.

Post-test inspection showed no apparent damage. Figures 16 and 17 show a pre-test side view and a post-test side view, respectively. Dummy chest and pelvic deceleration showed overshoot and reached peak magnitudes of 15.3G and 7.65G, respectively.

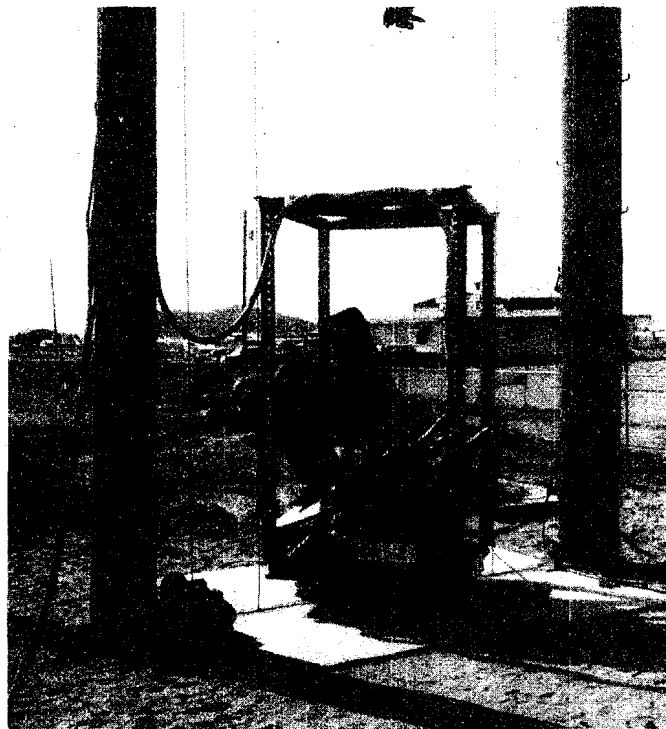
Figure 18. Seat Configuration 1 after Test 2.

Post-test inspection revealed no apparent damage. Figure 18 shows a post-test side view. Dummy chest and pelvis showed overshoot with vertical decelerations of 18.3G and 15.8G, respectively.

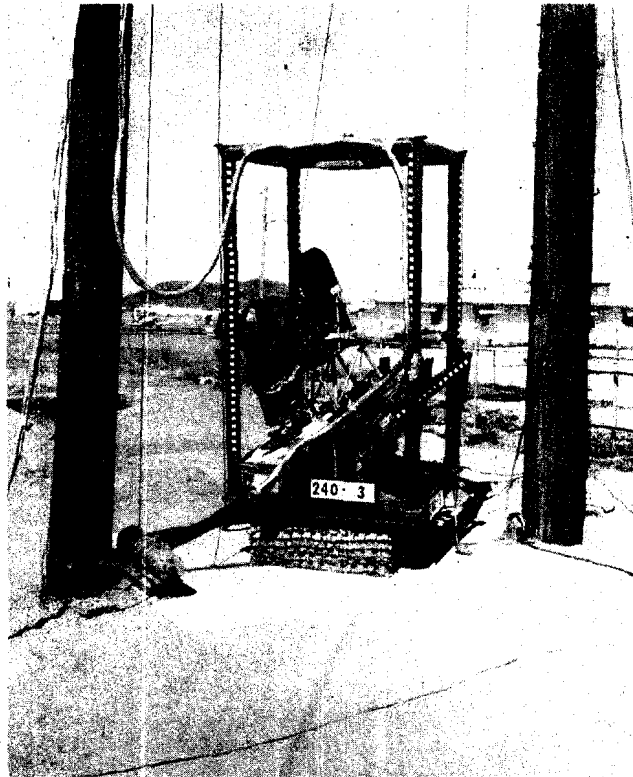
Figure 19. Seat Configuration 2 after Test 3.

Post-test inspection revealed no apparent damage. Figure 19 shows a post-test inspection side view. Peak dummy chest and pelvic vertical decelerations were 15.G and 7.5G, respectively.

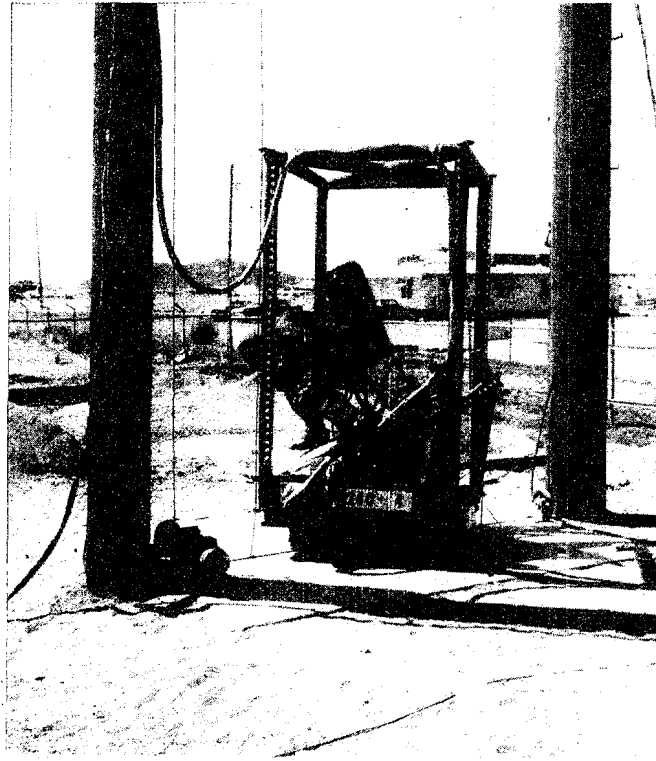
Figure 20. Seat Configuration 2 after Test 4.

Post-test inspection revealed no apparent damage. Figure 20 shows a post-test side view. The dummy chest showed a very high peak vertical deceleration of 33.2G. The peak pelvic deceleration was 13.4G.

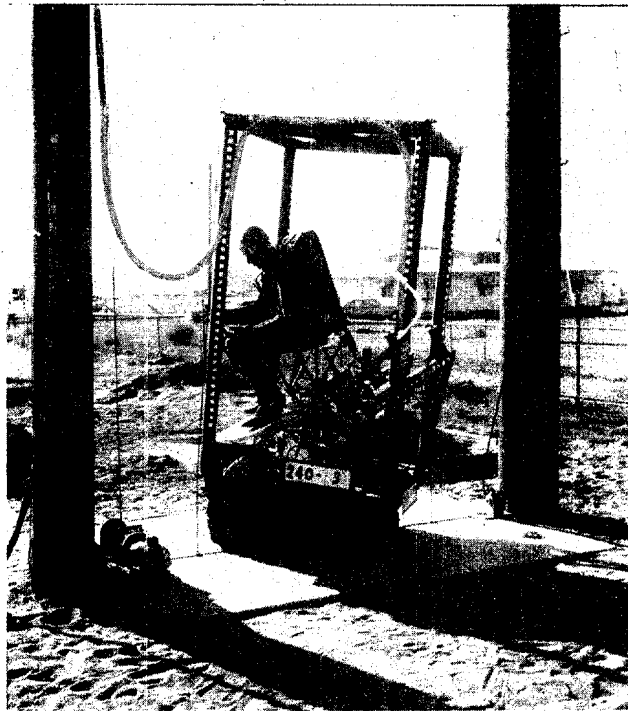
Figure 21. Seat Configuration 3 after Test 5.

Post-test inspection revealed no apparent damage. Figure 21 shows a post-test seat side view. Peak dummy chest and pelvic vertical decelerations were 12.7G and 7.31G, respectively.

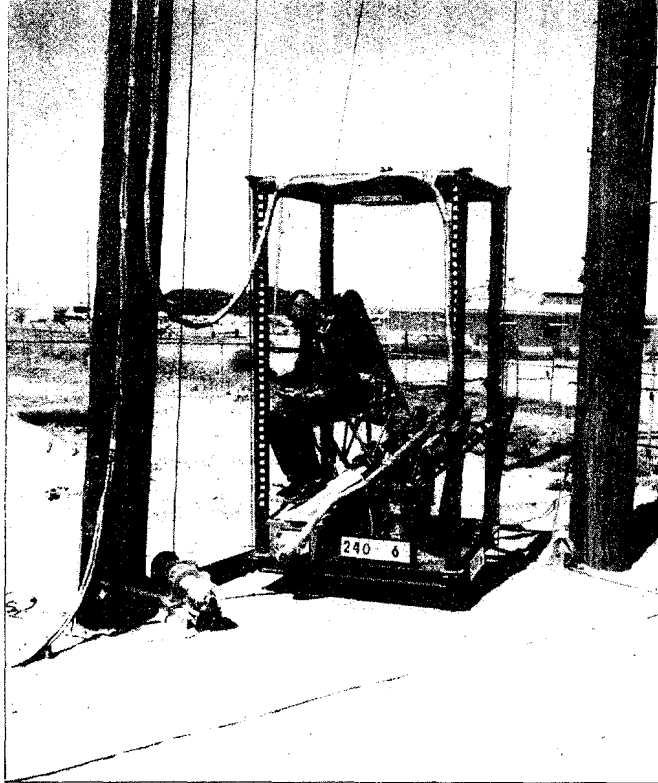
Figure 22. Seat Configuration 3 after Test 6.

Post-test inspection revealed no apparent damage. Figure 22 shows a post-test side view. Peak dummy chest and pelvic vertical decelerations were 30.9G and 14.3G, respectively.

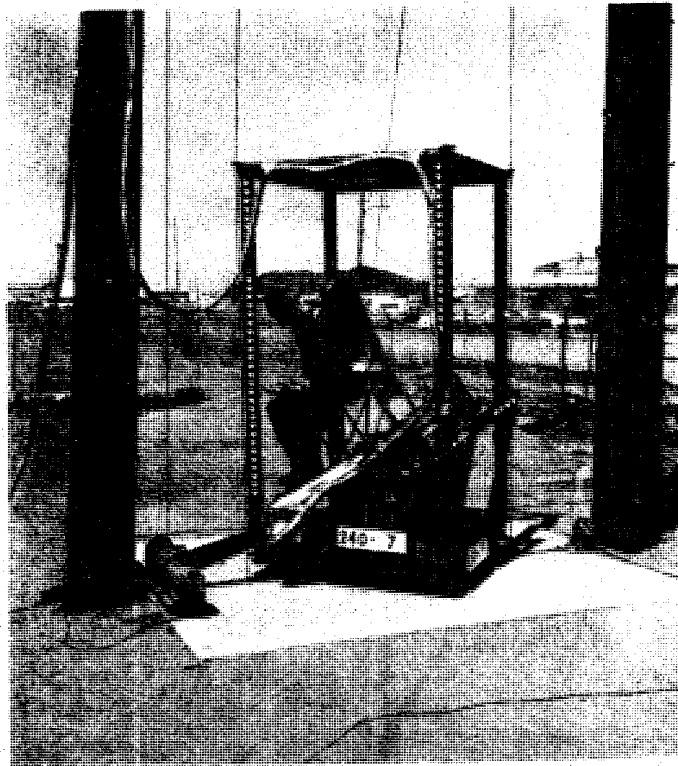
Figure 23. Seat Configuration 3 after Test 7.

Post-test inspection revealed no apparent damage although, when the test film was viewed, the seat back was seen to deflect elastically a considerable distance upon impact. Figure 23 shows a post-test side view. Peak dummy chest vertical deceleration was 28.8G.

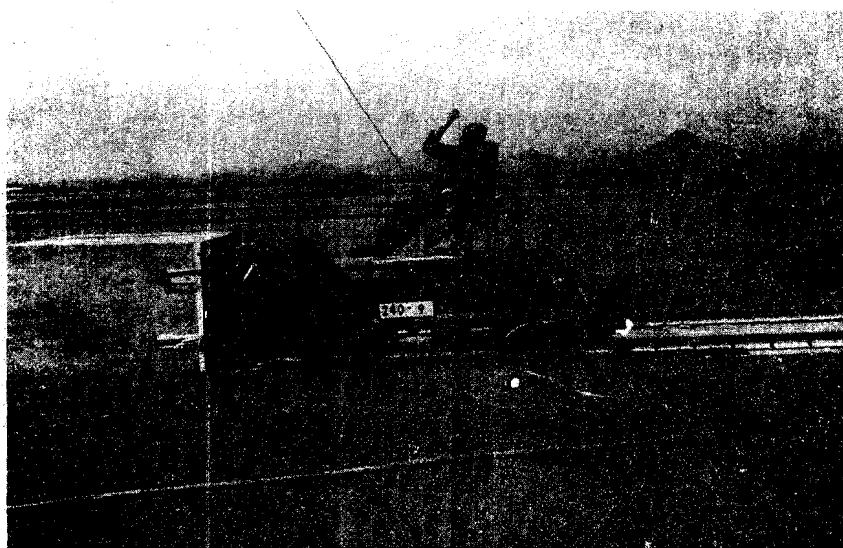
Figure 33. Seat Configuration 1 After Test 9.

Post-test inspection revealed no apparent damage. Figure 33 shows a post-test side view. The maximum deceleration recorded in the dummy was 5.85G measured in the vertical direction in the pelvis.

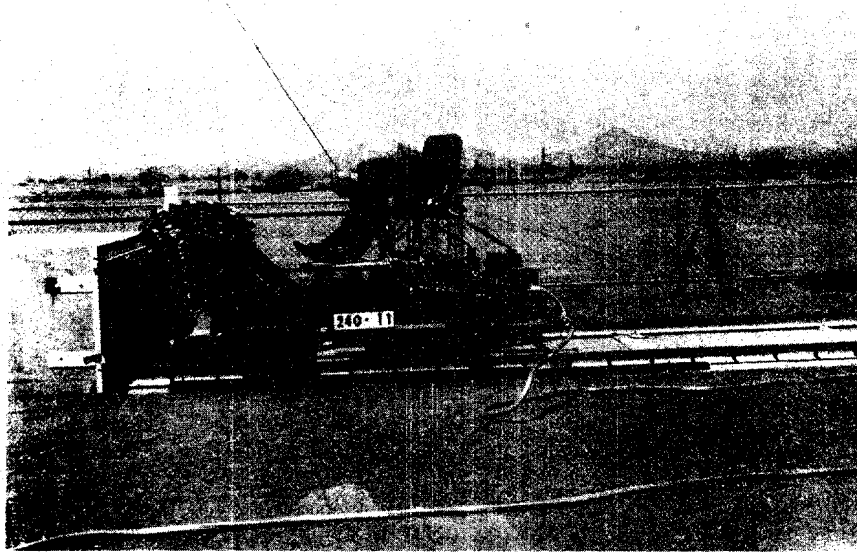
Figure 38. Seat Configuration 2 after Test 11.

Post-test inspection revealed no apparent damage. Figure 38 shows a post-test side view. The maximum deceleration measured in the dummy was 12.1G vertical in the chest.

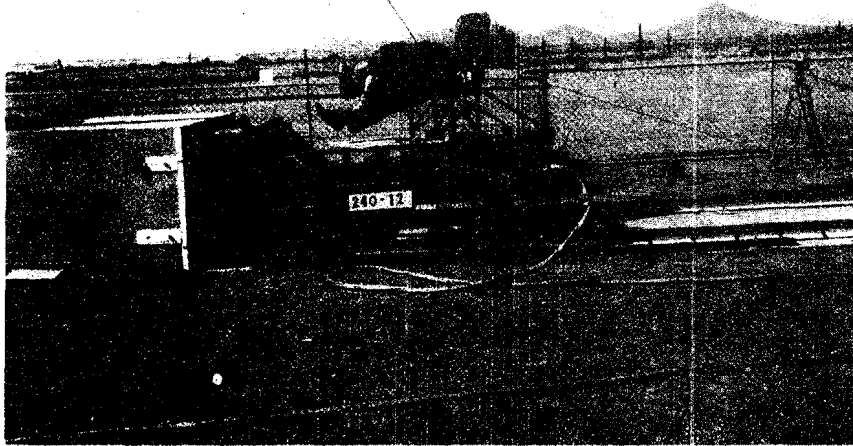
Figure 39. Seat Configuration 2 after Test 12.

Post-test inspection revealed no apparent damage. Figure 39 shows a post-test side view. There was a relatively high vertical chest deceleration as the dummy jack-knifed violently. The highest deceleration was 24.8G in the vertical direction in the chest.

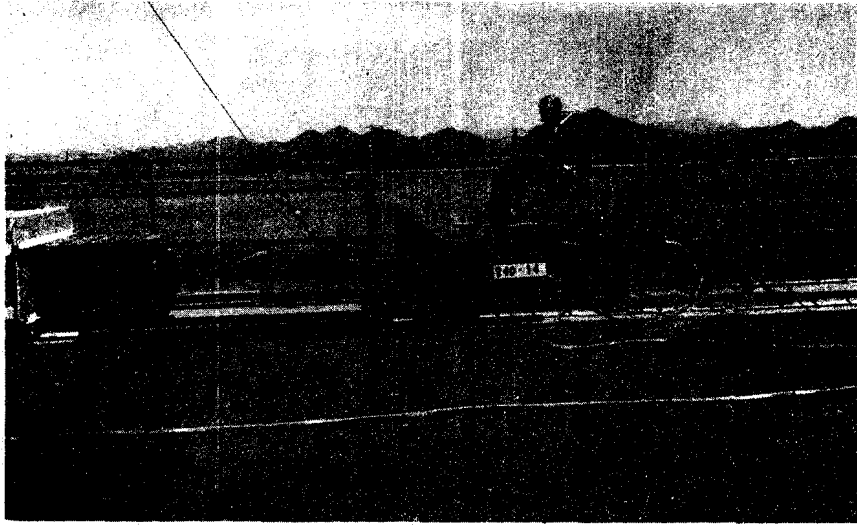
Figure 41. Seat Configuration 3 Before Test 14.

Test 14: This test on seat Configuration 3 was planned to be an 8G resultant pulse with a velocity change of 35 fps and a rate of onset of 400 G/sec. The resulting input pulse had a peak of 7.74G, a velocity change of 32.9 fps, and a rate of onset of 185 G/sec. Figure 41 shows a side view of the seat mounted in the accelerator sled just prior to test.

Post-test inspection revealed four failures as shown in Figures 42 thru 44. The seat back tube failed at the back brace tube bolt holes, the left lap belt ring weld failed, the right front seat joint started to pull loose, and the seat canvas failed. The dummy moved out of the seat and onto the left side of the sled; however, the dummy and instrumentation were not damaged. (See Figures 41 thru 44.) The maximum dummy deceleration was measured in the chest and was 13.9G in the vertical direction.

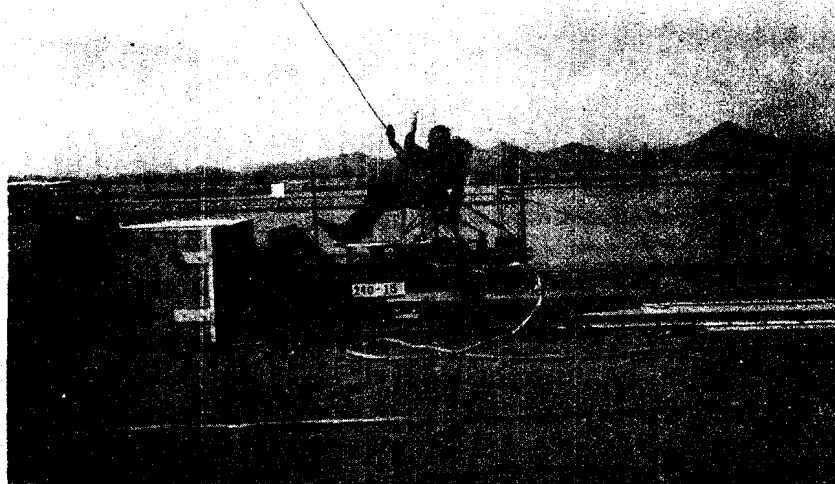
Figure 46. Seat Configuration 4 After Test 15.

Post-test inspection revealed four failures or incipient failures. The right and left side longitudinal seat tubes failed at the back brace tube joints (shown in Figures 47 and 50), the left side steel seat back tube was bent at the stiffener, the left side back brace tube was bent, and the male tangs on the upper end of all four leg assemblies were bent. The leg fittings were probably bent as a result of load shifting after failure of the longitudinal seat tubes. (See Figure 49) The maximum deceleration measured in the dummy was 8.91G in the longitudinal direction in the pelvis.

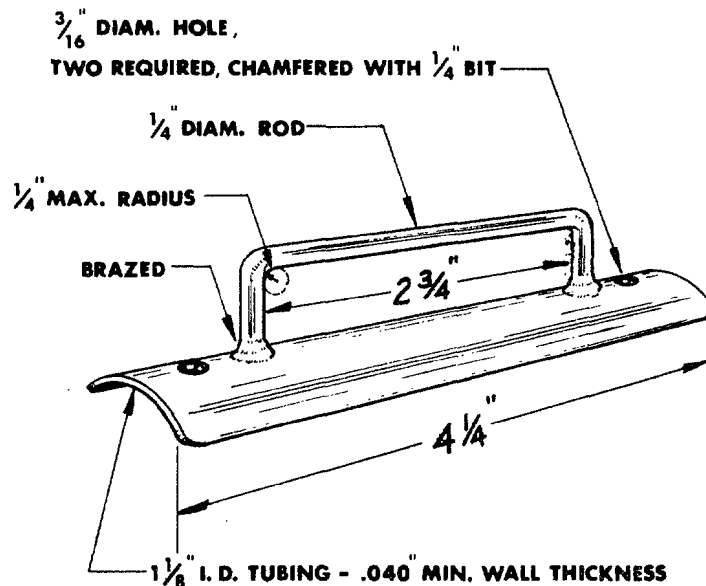
Figure 59. Shoulder Harness Retention Loop

The following drawings give sizes and specifications of the two nonstandard parts of the kit. Use any aircraft quality #10 bolts of appropriate length for attachment.

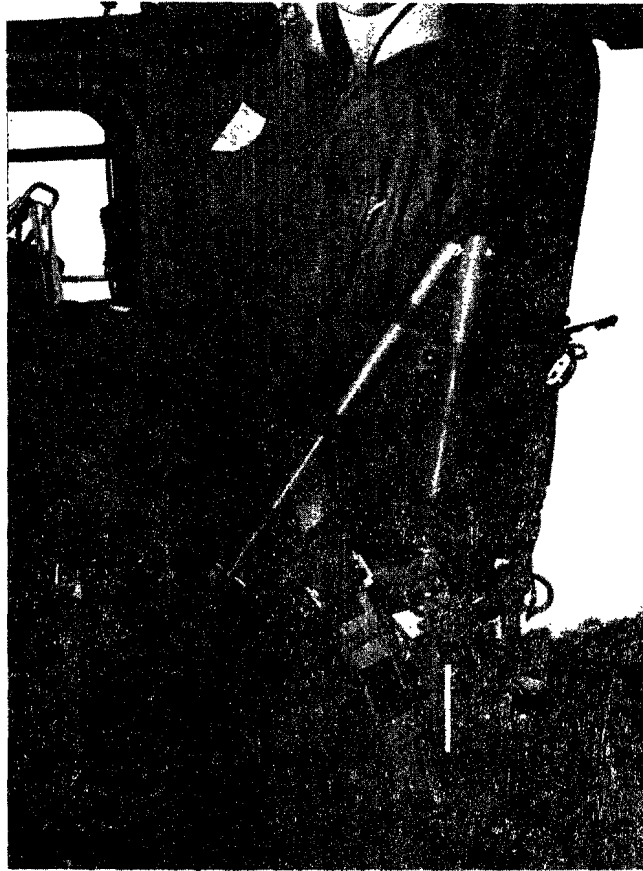
Figure 61. Correct Installed Position of Seat with Kit. Note Routing of Lap Belt Secured by Canvas Strap on Side.

The current lap belt attachment rings on the sides of the seat are not to be used in their present state. If for any reason it is necessary to attach any restraint system to one of these rings, follow this procedure: Cut the entire weld area out, bevel the ends completely, bend the ring to bring the ends together, reweld completely and thoroughly, making sure the entire area is uniformly heated, allow the area to anneal by natural air cooling.

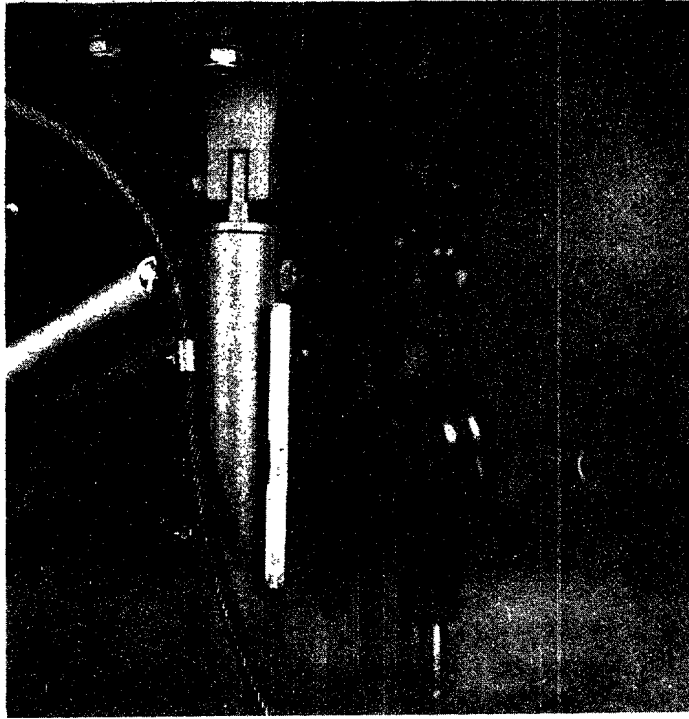
Figure 64. Correct Installed Position of Inertia Reel Mounting Plate. Note Locking Cable Secured to Upper Mounting Bolt.
